# Description of Work

- Two wafers were submitted for KLA2139 defect inspection post Copper CMP using an MIT854 pattern.
- A recipe was created to catch all defect types present on these wafers.
- Images were captured on a sample of defects from each wafer.
- A sample of defects were reviewed in a review SEM to characterize defect types.
- Defects were classified manually using a combination of SEM and optical images.

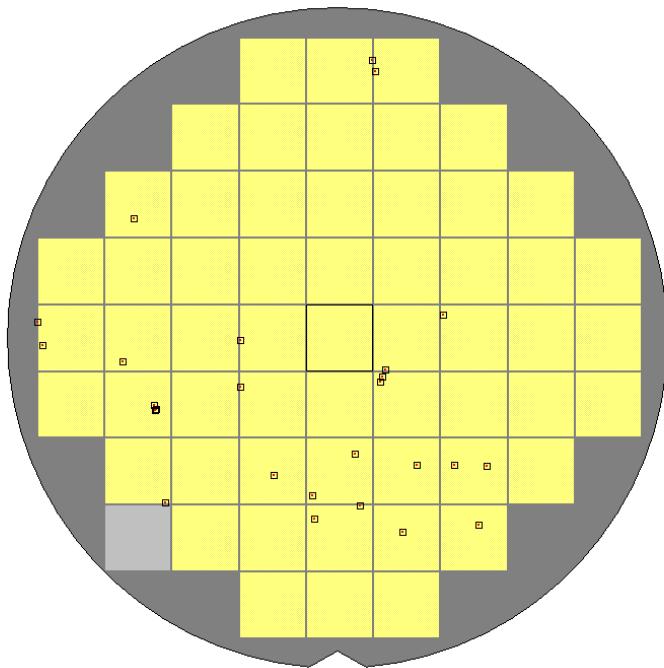
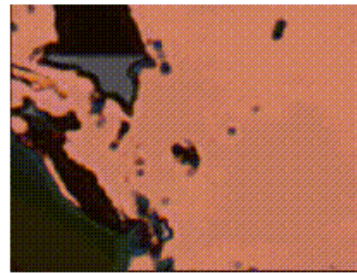
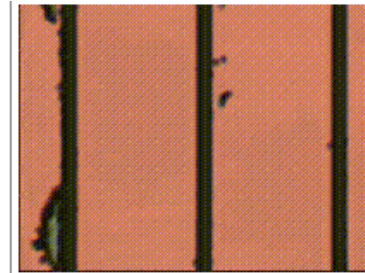
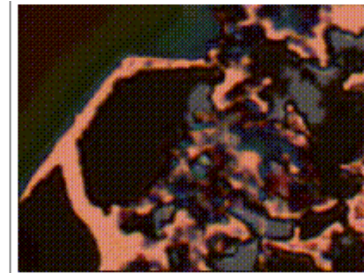
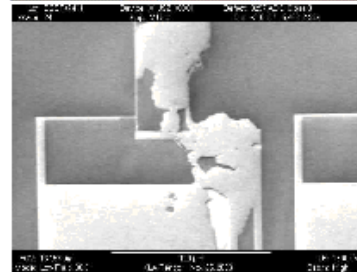
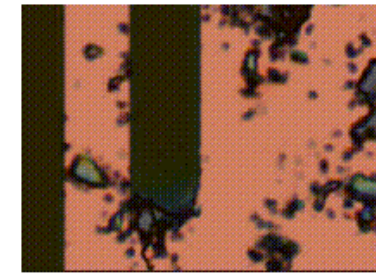
# Defect Class #100: Mechanical Damage

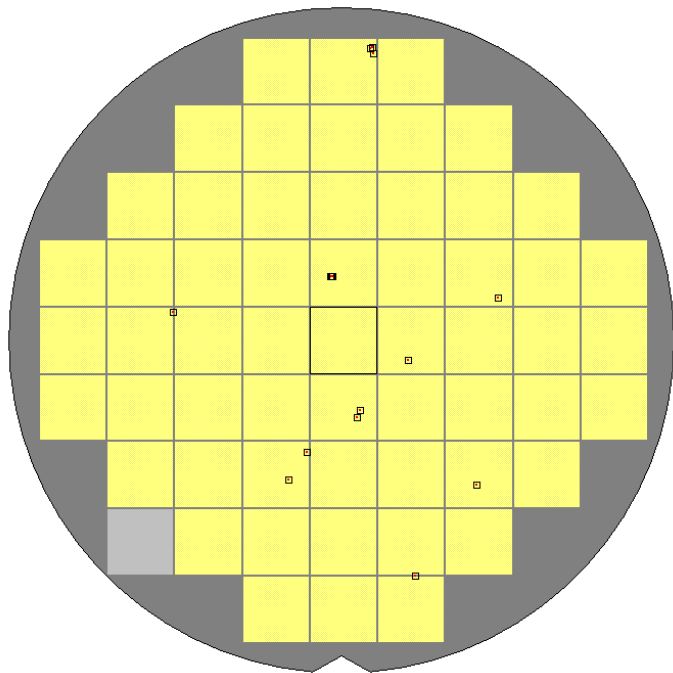
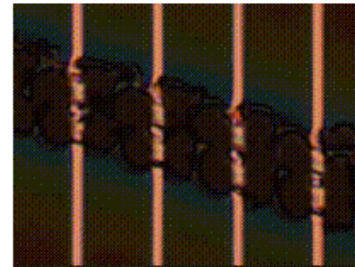
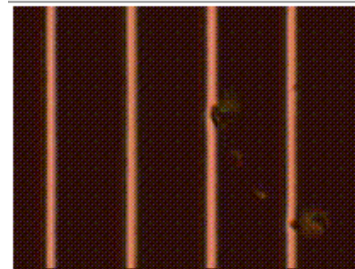
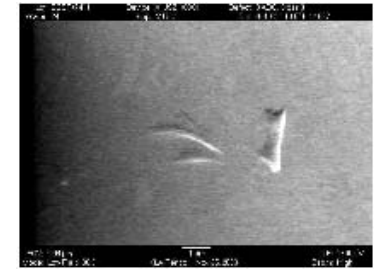
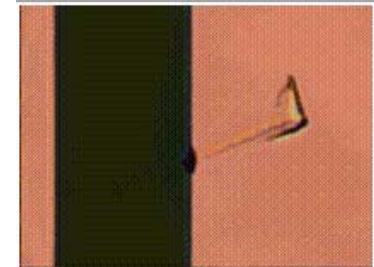
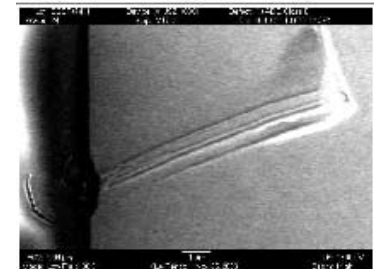
# Defect Class #101: Surface Scratches

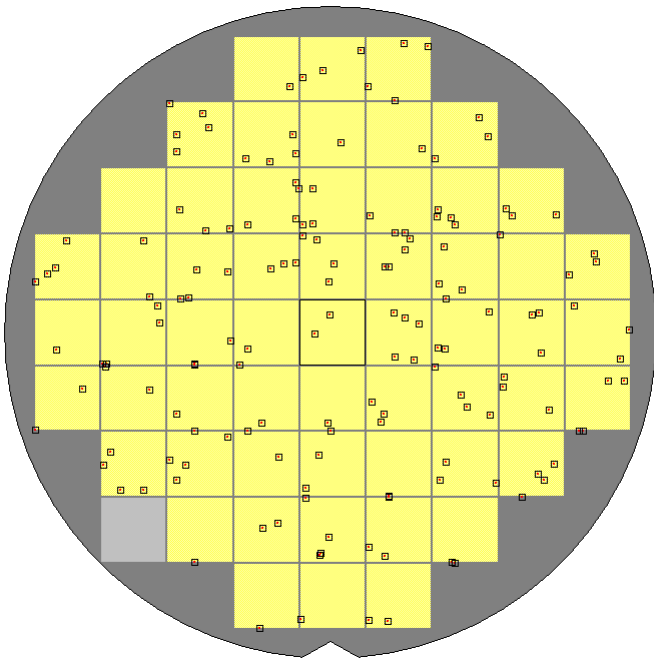
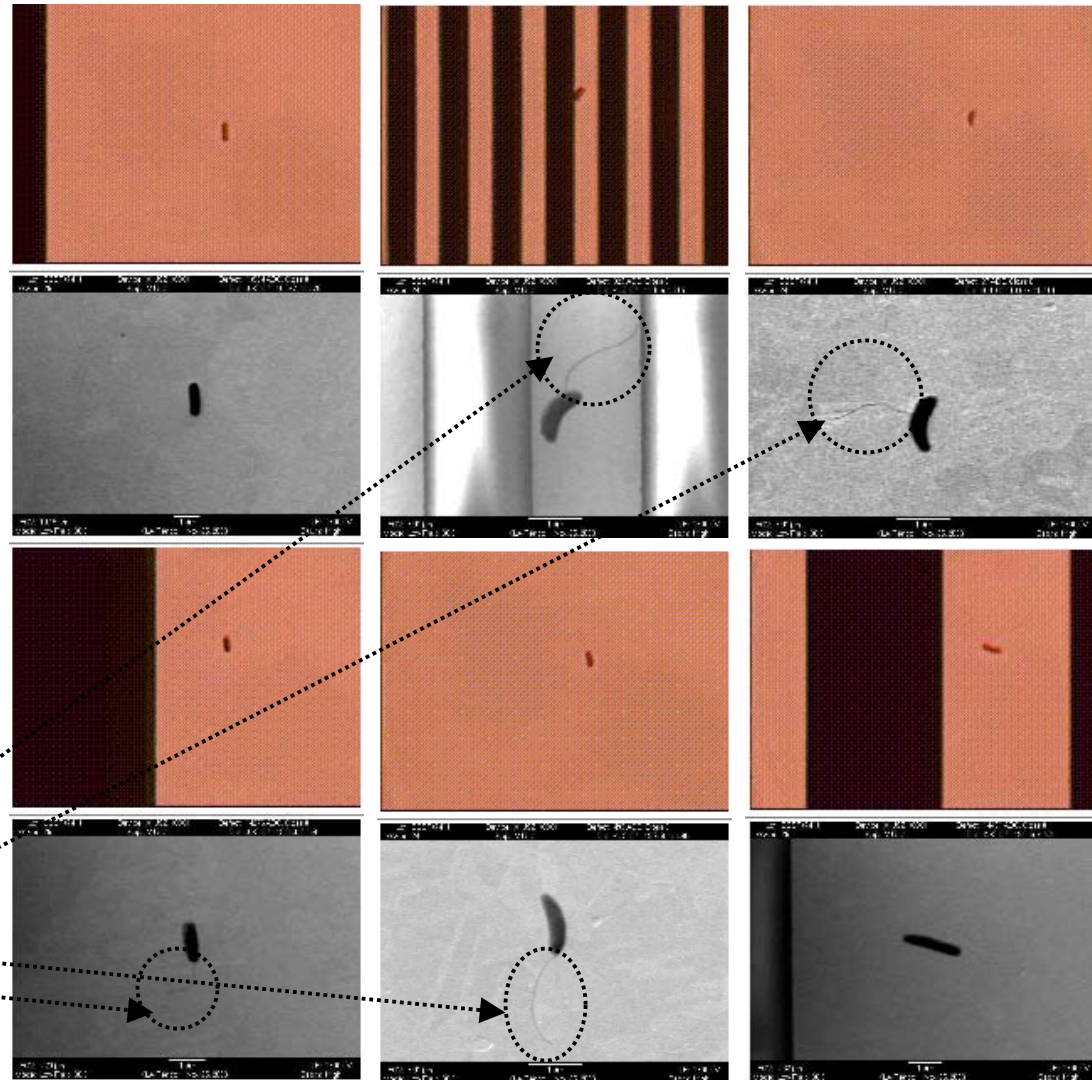
# Defect Class #102: Organic Blobs

Many of these defects have a defined "tail" when viewed in an SEM, suggesting that these defects might be biological in origin

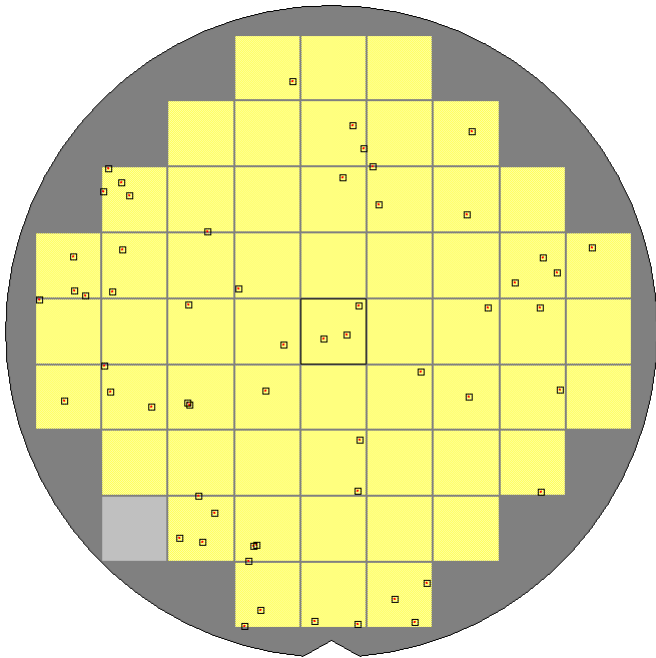
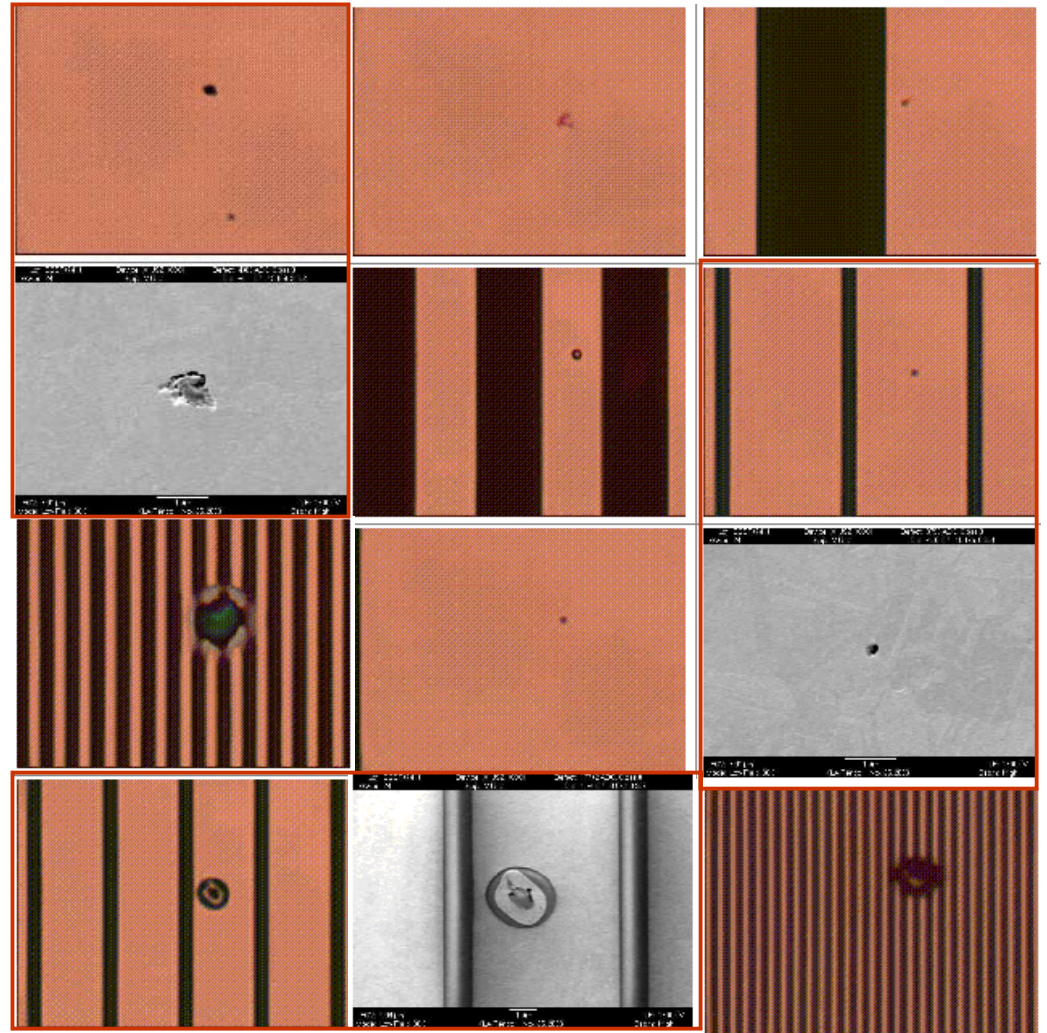
# Defect Class #103: Particles/Tearouts

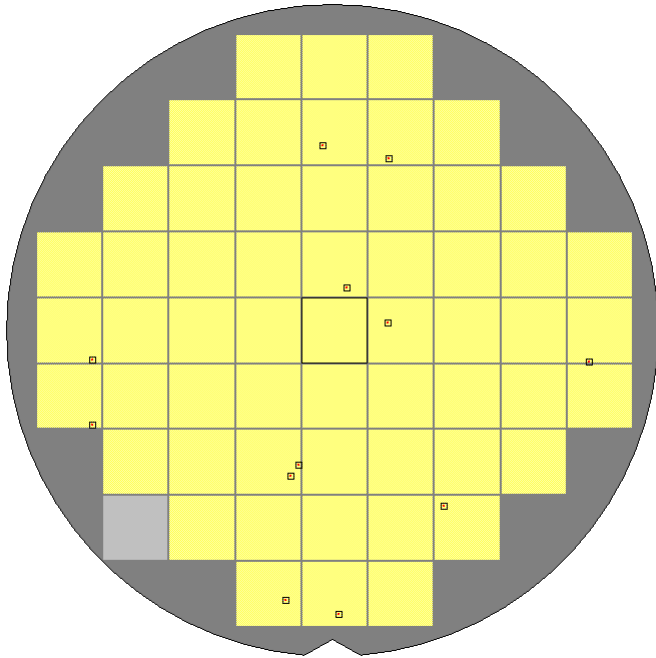
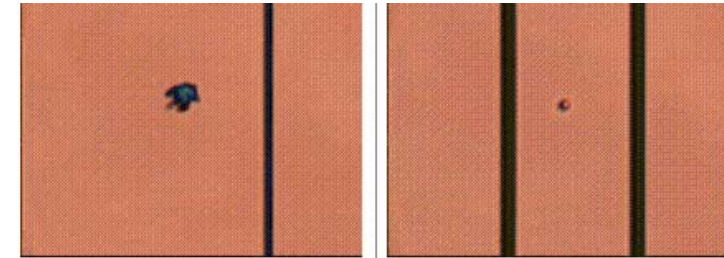
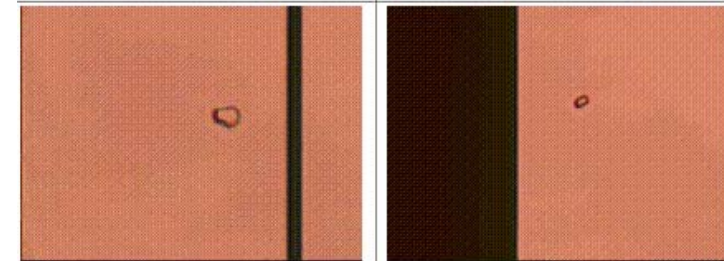
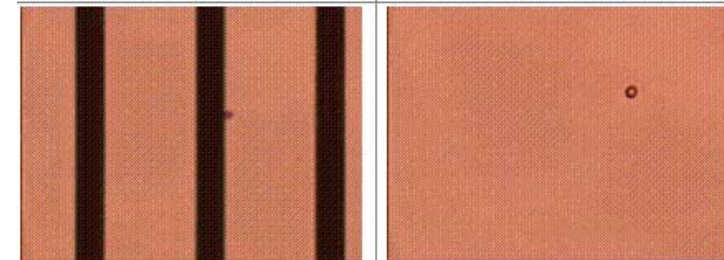
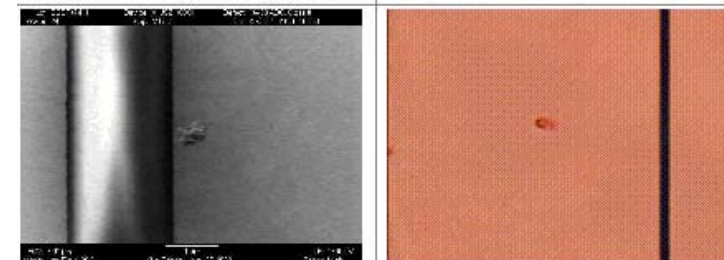
# Defect Class #104: Organic Residue

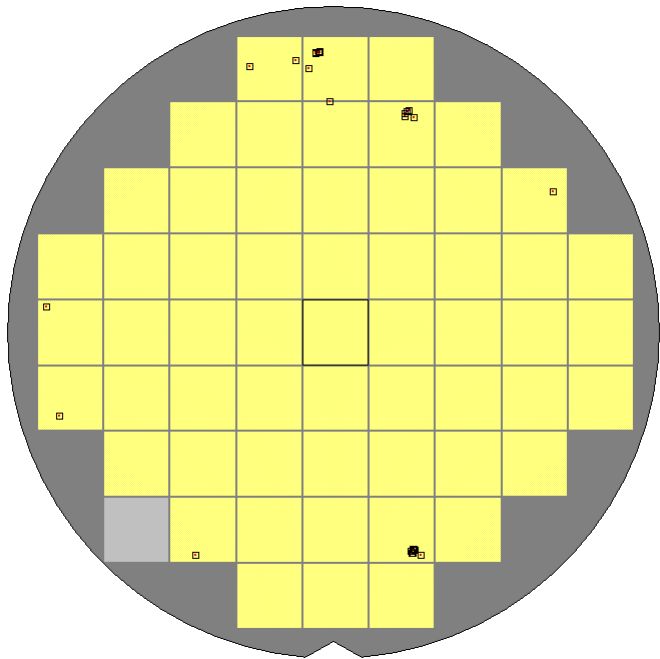
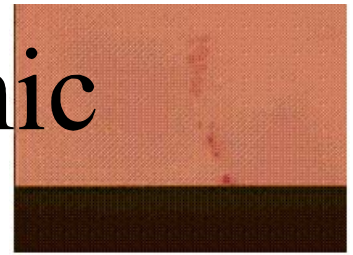
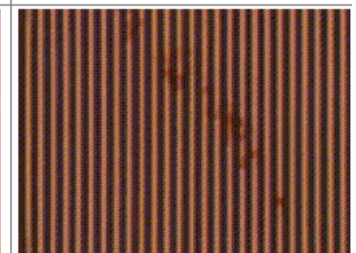
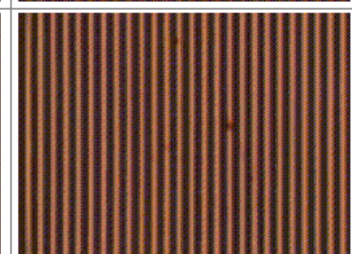
# Defect Class #105: Organic Residue
